Mid-America Inspection Services LLC

Property Inspection Report

555 Parkview Lane, Paradise, MN 55679
Inspection prepared for: John Smith & Jane Smith
Real Estate Agent: FSBO -

Date of Inspection: 6/12/2018 Time: 4:00 pm
Age of Home: 99 yrs Size: 1,648 sq ft

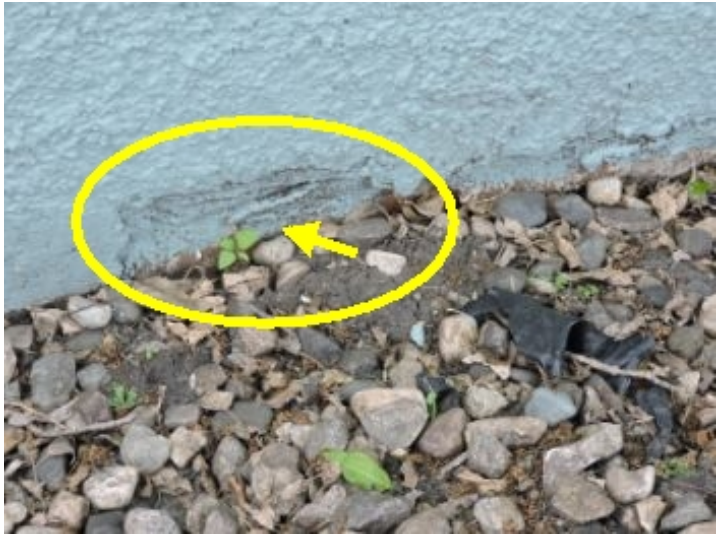
• The foundation protective surface has damage. Recommend having properly repaired to both help reduce chances of moisture entering and causing further damage and to help improve appearances.

Example view - damage to foundation protective covering

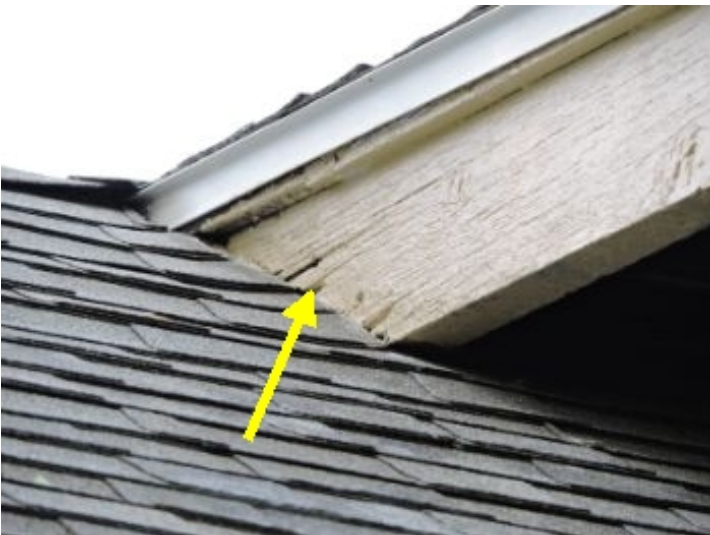
Example view - worn paint/possible decay at wood fascia - SW

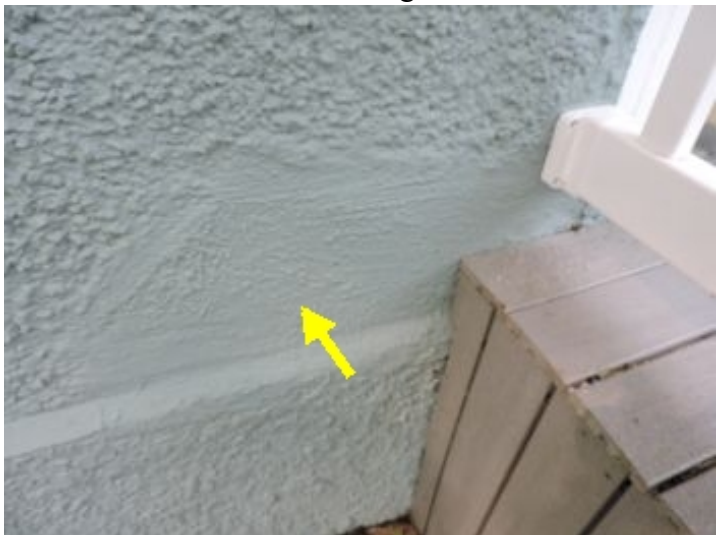
Example view - evidence of prior repairs to stucco

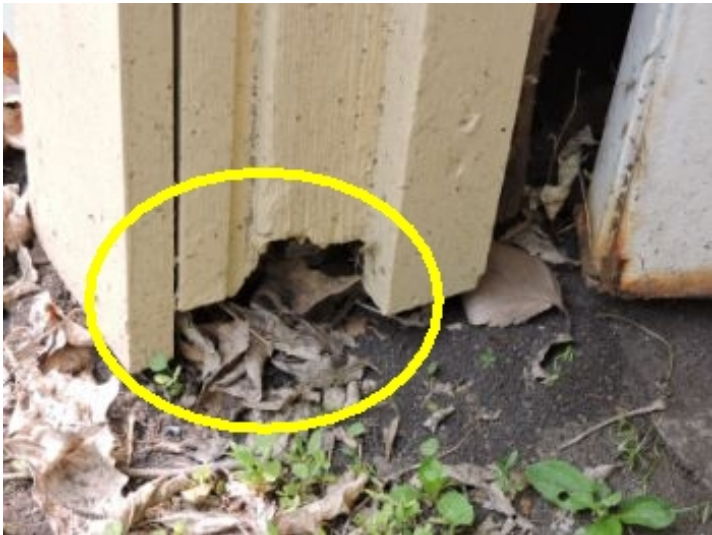
Example view - decay at garage passenger door frame

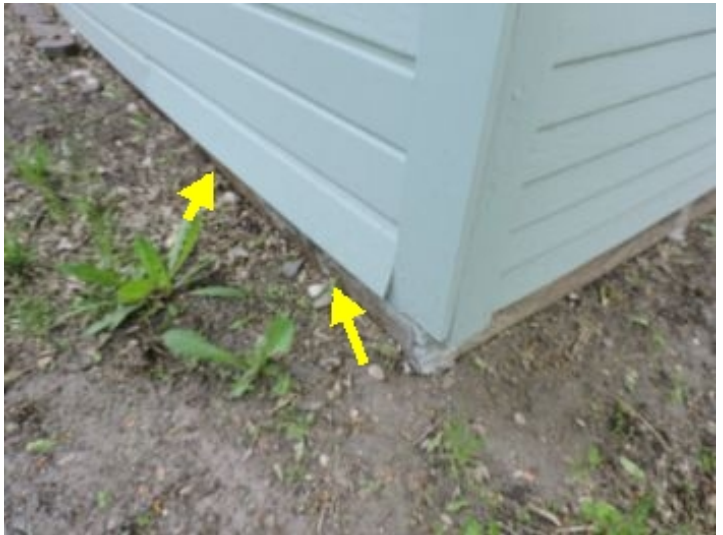
Example view - bulge at east side of garage siding

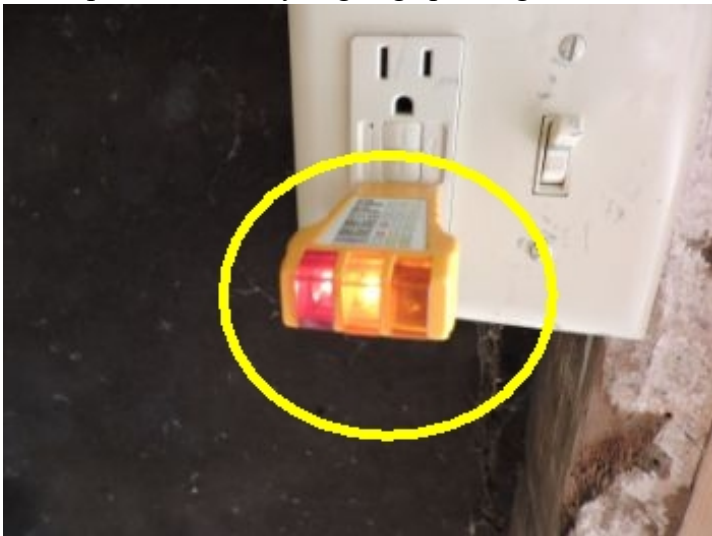
Example view - reversed polarity at garage GFCI outlet

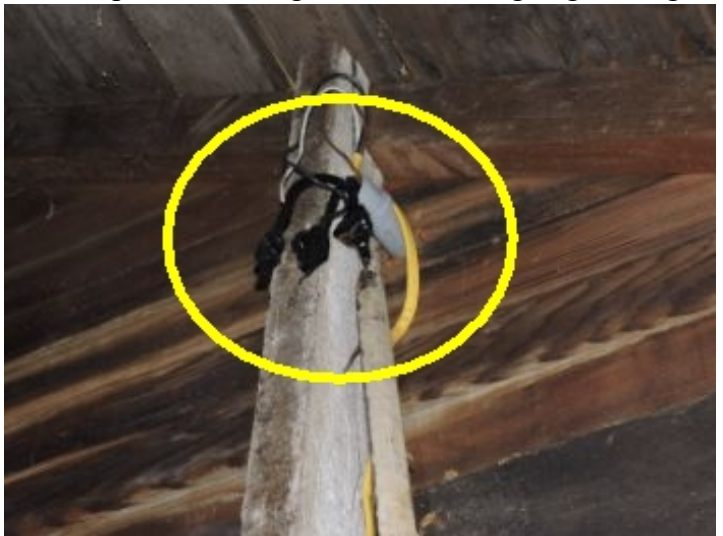
Example view - improperly terminated electrical wires - garage

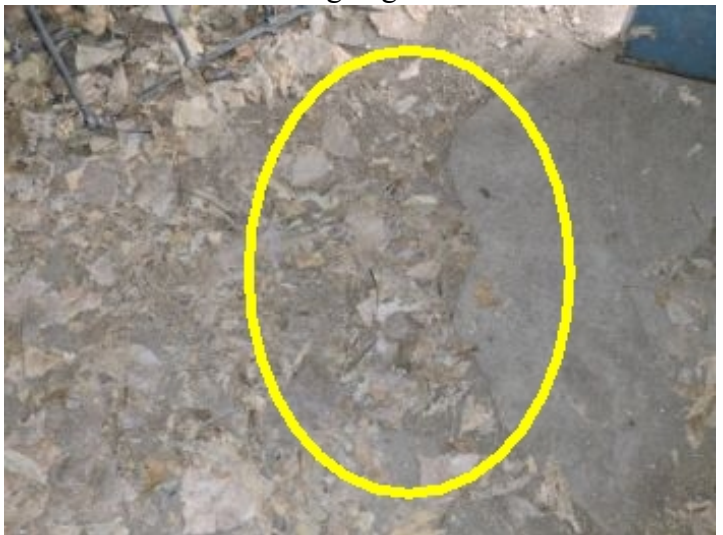
Example view - cracked/damaged floor - garage

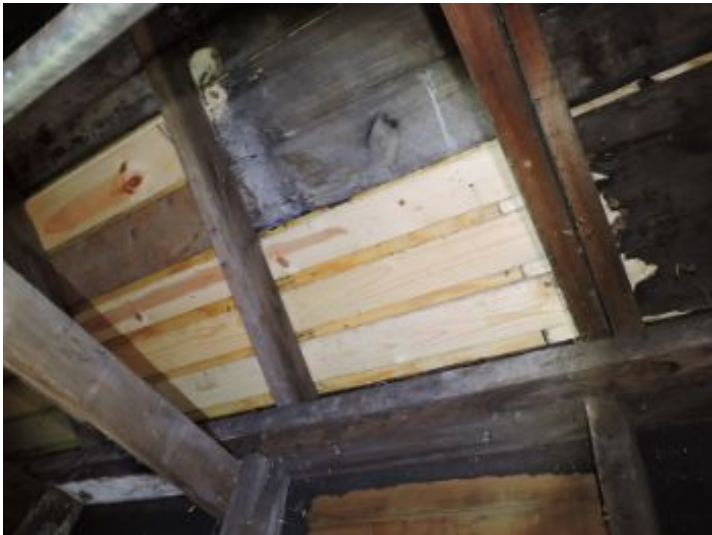
Example view - prior repairs to board sheathing - garage

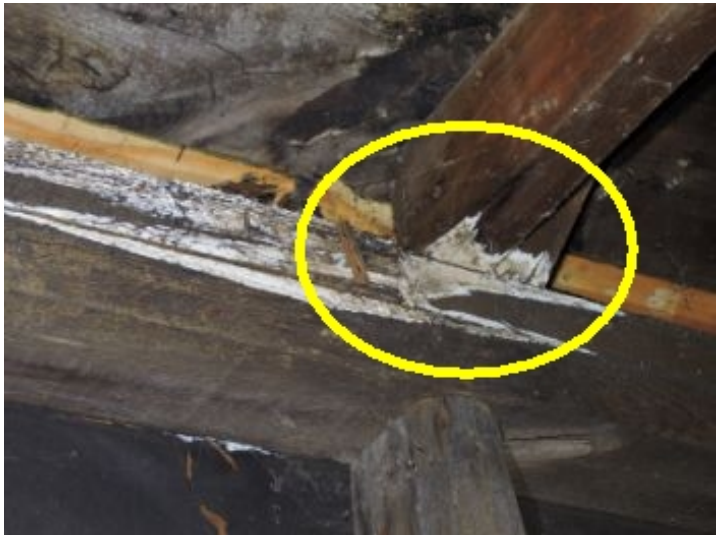
Example view -decay at walls/rafters - garage

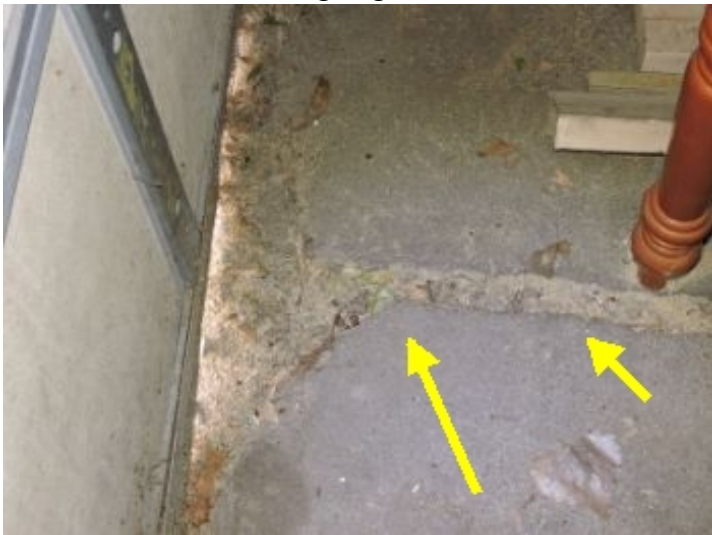
Example view - cracked/damaged garage floor

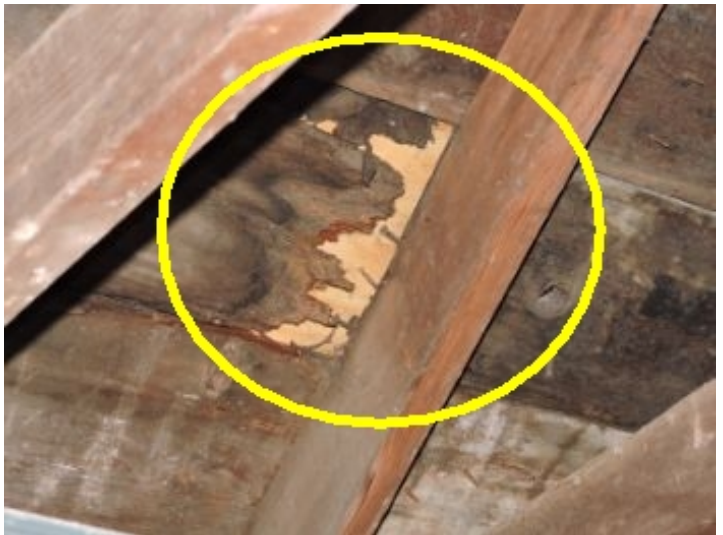
Example view - damage/prior repairs to board sheathing - garage

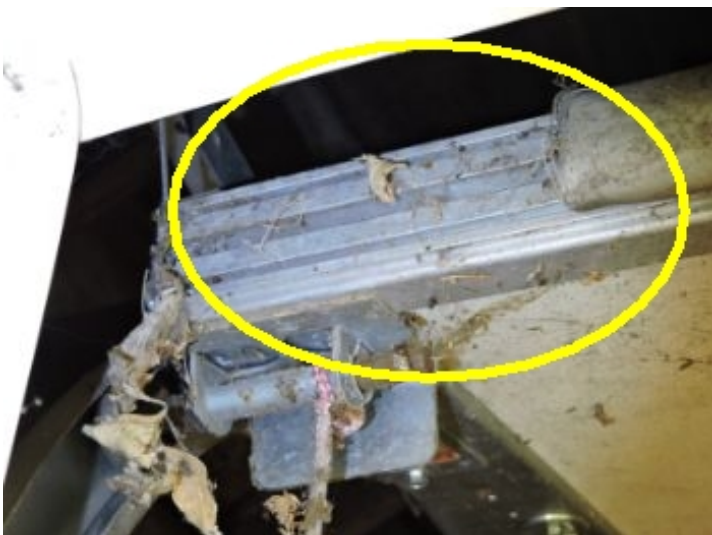
- +++ Vehicle Door Opener +++
- The garage vehicle door is manually operated.
- +++ Garage Door +++
- Garage vehicle door bottom weatherstripping was worn/damaged. Recommend installing new stripping to help prevent moisture/pest intrusion.

Example view - damaged weather stripping - garage door

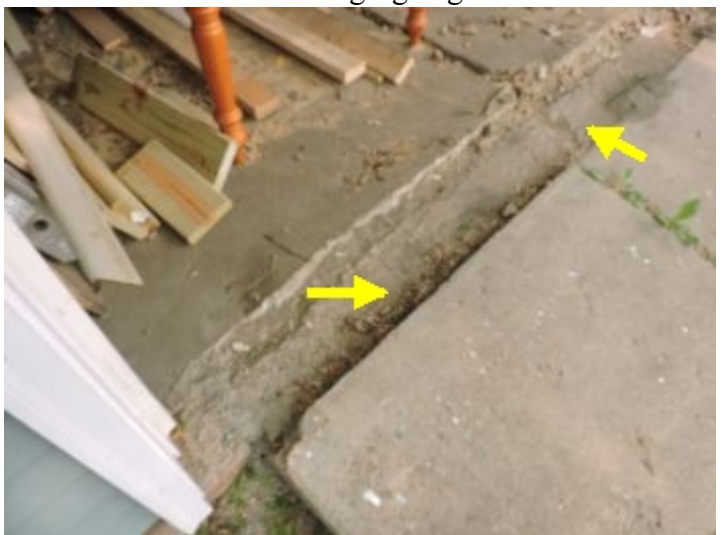
Example view - damaged/settled concrete floor - garage driveway

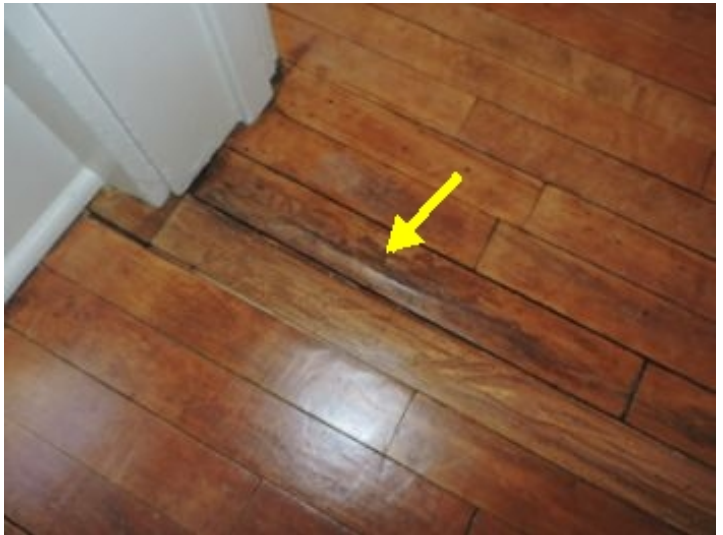
- +++ Walls +++
- The walls had no visible significant defects at the time of the inspection.
- +++ Ceiling +++
- The ceiling has no significant defects visible at the time of the inspection.
- +++ Floor +++
- Soft spot in floor covering noted at the threshold between the foyer and the living room. This may be the result of decay/damage, a transition point or other factors. At time of the inspection no significant damage was observed. Recommend monitoring for changes and budgeting for additional evaluation as needed by a qualified building professional.

Example view - soft area at floor - foyer

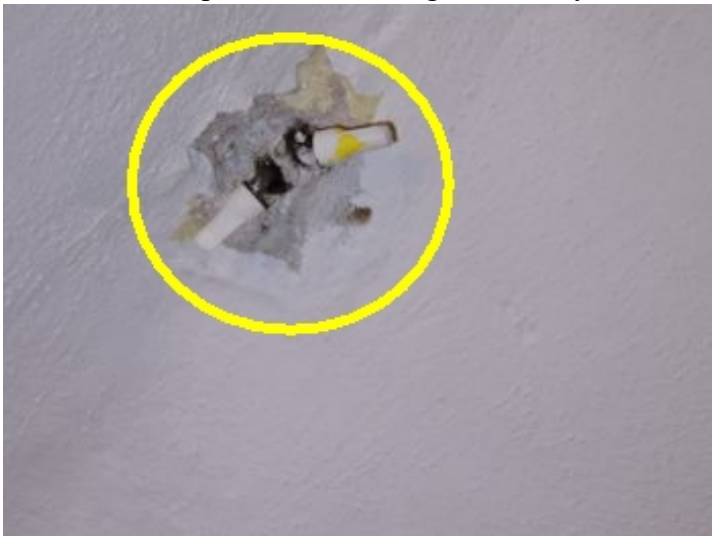
Example view - improperly terminated electrical wires
- NW bedroom closet

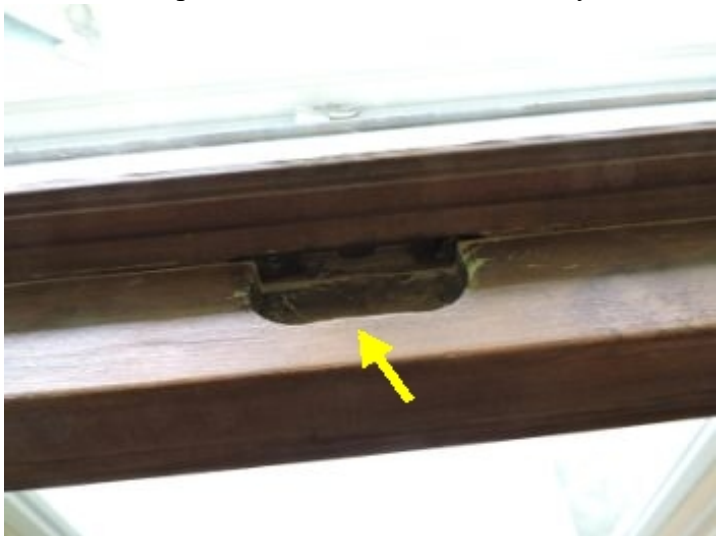
Example view - missing/damaged latch hardware -
bathroom window - north

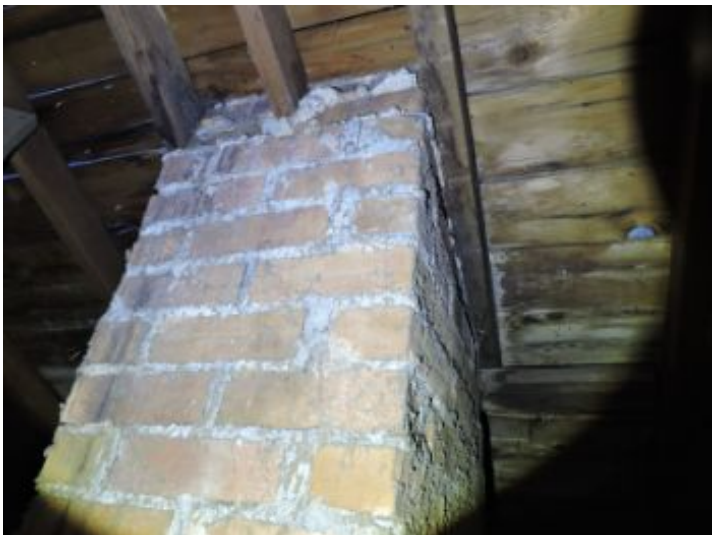
- +++ Chimney in Attic +++
- Maintenance Tip: Efflorescence visible on the chimney. This is often a sign of water infiltration/exfiltration and can be a precursor of masonry deterioration. Recommend monitoring for any further changes that might indicate the leaks are still active.

Example view - chimney/stains from prior leaks

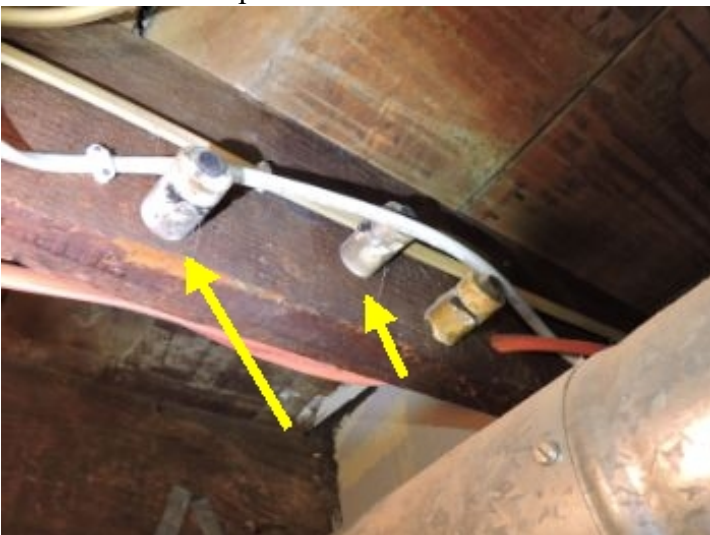
Example view - abandoned knob and tube electrical - basement

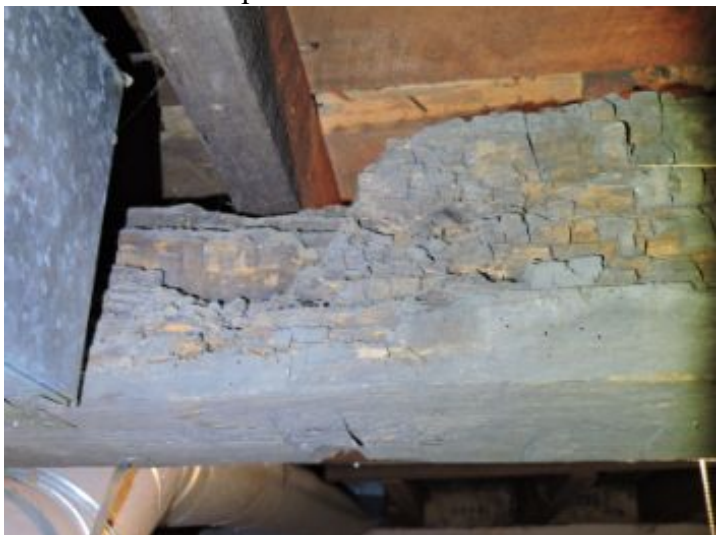
Example view - decay/damage to main support beam - basement

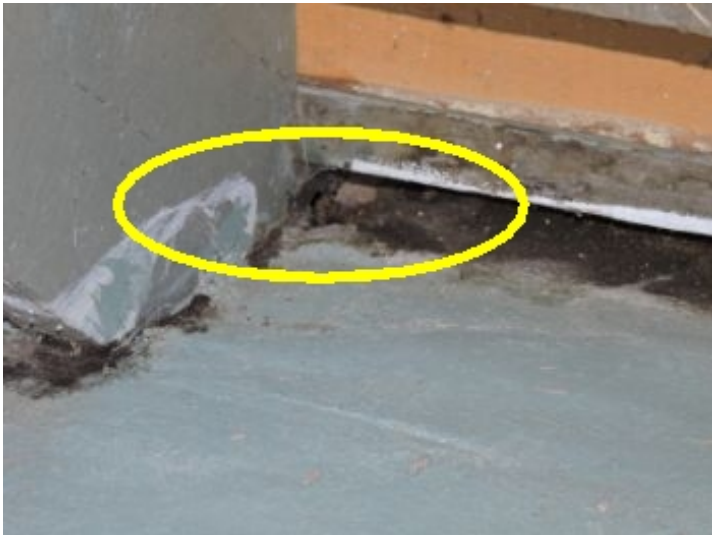
Example view - decay at basement stair stringer(s)

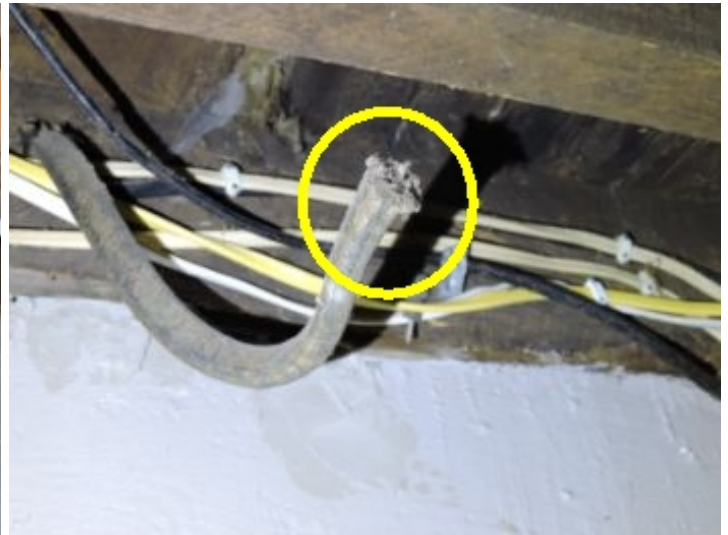
Example view - improperly terminated electrical wire - basement above main panel

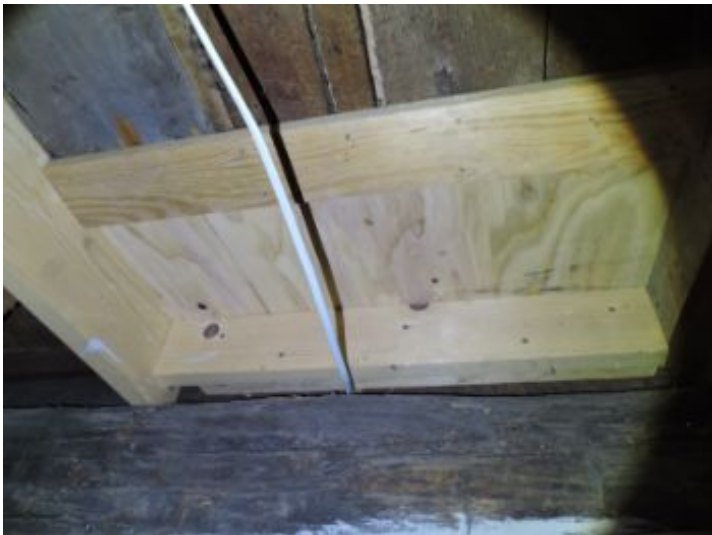
Example view - prior repairs to basement ceiling

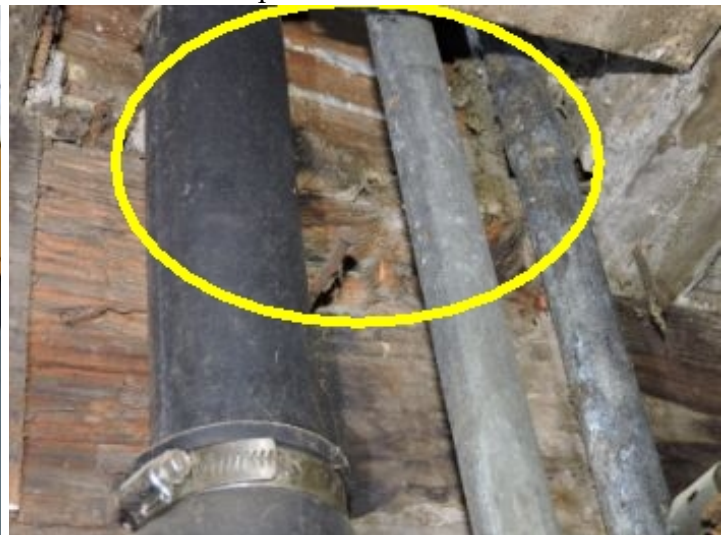
- +++ Beams and Posts +++
- There are no significant defects visible in the post(s).
- +++ Floor Joists +++
- There is damage/decay to some of the floor joists. Recommend having evaluated further and corrected by a building professional to help restore structural integrity.
- +++ Beams and Posts +++
- There is some damage/decay to the beam(s). Recommend having evaluated by a building professional to help determine a course of action.

Example view - decay at joists - basement

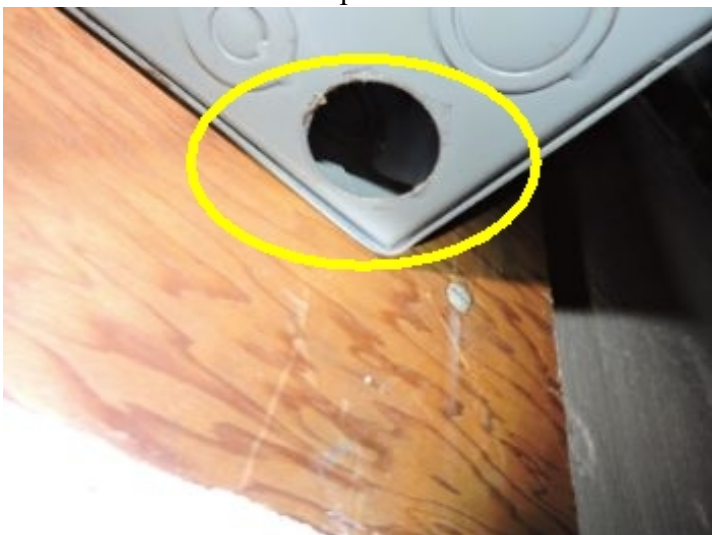
Example view- missing knockout - main electrical panel

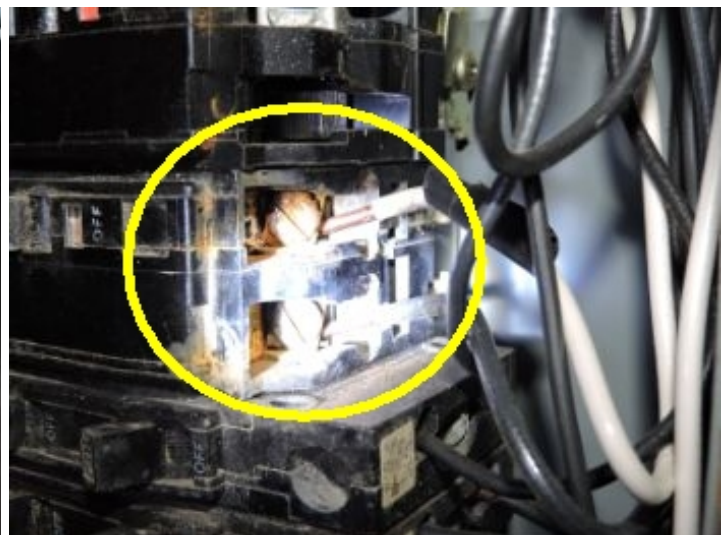
Example view - rust/corrosion at breakers - main electrical panel

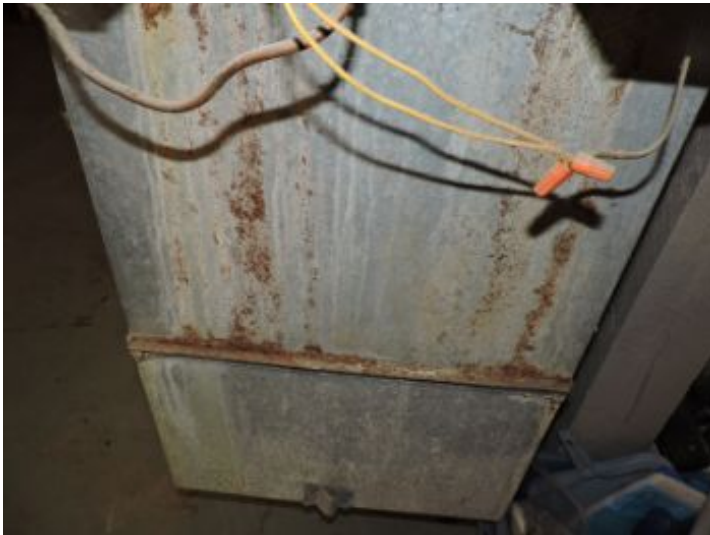
Example view - rust/corrosion at forced air ducts under humidifer

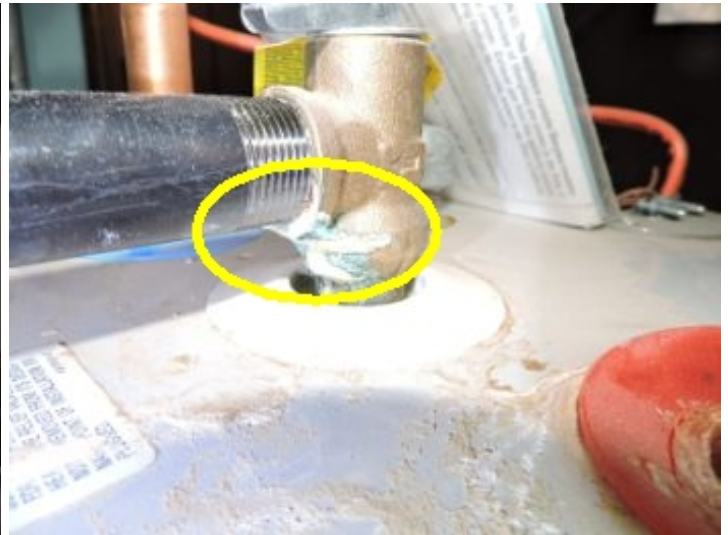
Example view - corrosion at TPR valve - water heater

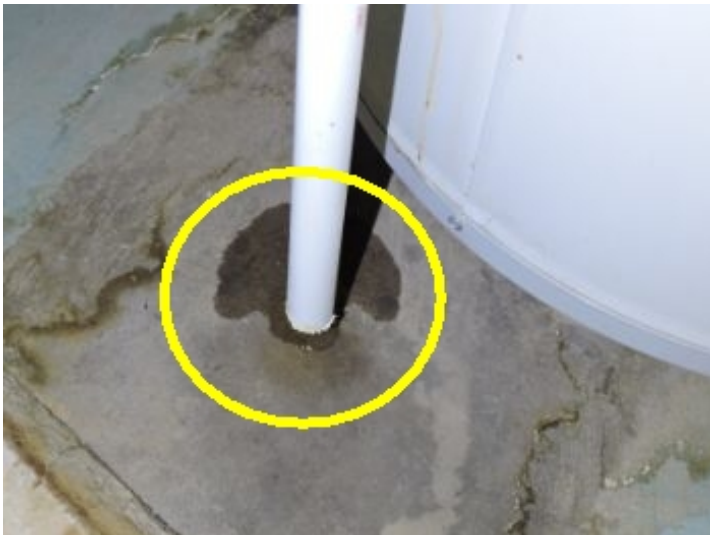
Example view - water discharge from water heater
